PETER KOTEŠ¹⁾
MIROSLAV BRODŇAN²⁾
MILAN CHANDOGA³⁾
TATIANA BACÍKOVÁ⁴⁾
WOJCIECH KUBISSA⁵⁾

THE ZLATNÉ BRIDGE - CONDITION SURVEY, TEMPORARY REMEDIAL WORKS REQUIRED DUE TO DANGEROUS CONDITION AND BRIDGE RESTORATION PROJECT

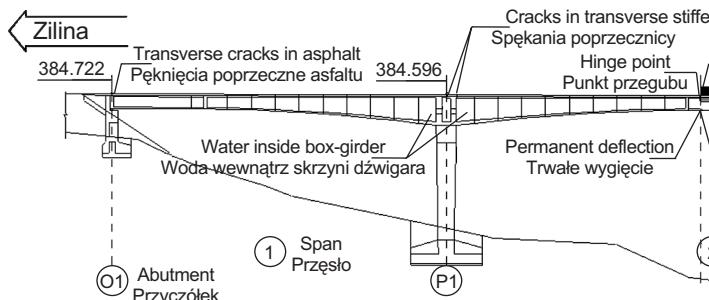
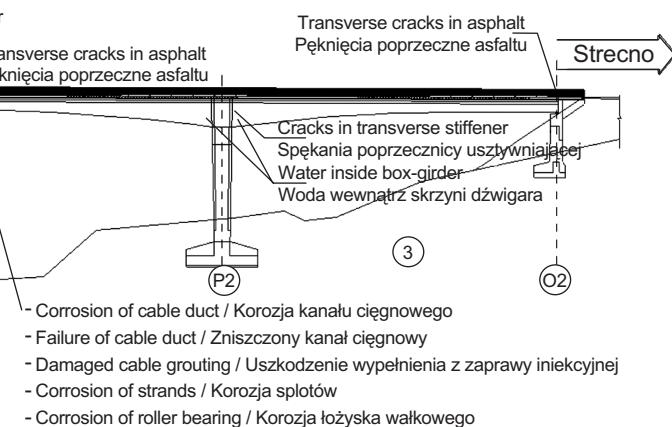
Fig. 3. Main failures and defects

Inspekcja potwierdziła uszkodzenia niektórych splotów sprzążających w strefie łożysk wałkowych (środek drugiego przęsła) obejmujące głęboką korozję lub całkowite zniszczenie kanałów ciegnowych, uszkodzenie zaprawy wypełniającej, uszkodzenie (pęknięcie) 30% splotów, korozję drutów (splotów), pęknięcia poprzecznicy usztywniającej, itd. Przeprowadzona analiza diagnostyczna potwierdziła, że głównym źródłem uszkodzeń jest przegub pośrodku drugiego przęsła (środkowego). Stwierdzono również trwałe wygięcie przęsła środkowego wywołane zmianami reologicznymi, które zaszły w betonie i ciegnach, a zanieczyszczenie strefy przegubu spowodowało zatrzymywanie wody i korozję splotów, zbrojenia i łożysk wałkowych i takie same były też skutki gromadzenia się wody nad podporami. Wygięcie ustroju nośnego (w strefie przegubu) spowodowało obniżenie komfortu jazdy na odcinku mostu (Rys. 3). Wyniki oględzin pozwoliły na ocenę ogólnego stanu obiektu zgodnie z instrukcją techniczną TP 9B/2005 [16] i zaliczenie go do klasy V oznaczającej stan niedostateczny.

The inspection confirmed strand damage in the area of roller bearing (in the middle of the second span) - deep corrosion of ducts, complete failure of ducts, damaged grouting, failure (snap) of 30% of strands, corrosion of wires (strands), cracks in the transverse stiffener, etc. The evaluation of the condition survey results confirmed that the main source of damages was the hinge in the middle of the second (middle) span. Other defects included permanent deflection in the middle span due to rheological changes in concrete and in strands, accumulation of dirt which retained water causing corrosion of the strands, the reinforcement and the roller bearings (accumulation of water over piers caused defects of the same kind). The resulting permanent deflection of the superstructure (in the hinge area) resulted in decreased riding comfort over the bridge (Fig. 3). Based on the visual inspection results it was possible to evaluate the overall condition (state) of the bridge and according to TP 9B/2005 [16] the bridge obtained class V, that is "poor" rating.

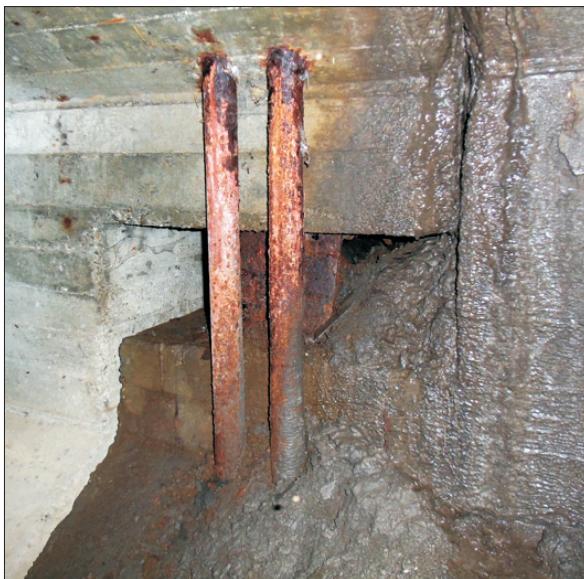
As it was previously mentioned, corrosion of prestressed strands which secured the position of the hinge in the middle of the second span has developed over time. This corrosion was caused by environmental loads imposed on the bridge and insufficient maintenance outlays. The considerable corrosion of strands caused gradual reduction of their cross-section leading to their rupture. Rupture of about 3-4 strands was noted already in the report from inspection during October and November 2011 [12]. At the time of the special condition survey, carried out in January 2012 [13] the number of broken strands increased to 6 out of the total number of 12, which is 50%. In February 2012 there were 9 broken strands out of the total number of 12. As a result excessive deformations and dynamic stresses occurred at the hinge each time a heavy vehicle weighing more than 30-40 tons passes the bridge. That bridge condition was considered critical, necessitating immediate implementation of the proposed measures as a precondition of further operation on the bridge. Reduction in the number of active strands changed the behaviour of the bridge structure in relation to the design, the results of evaluation and behaviour during long-term operation. The following administrative measures were proposed:

Fig. 4. View at the original cables

Replacement of corroded and ruptured strands of 4.5 mm wires was proposed as an immediate physical measure. Monostrand strands with corrosion-protection were used. In view of the expected restoration of the bridge structure to take place in the near future which should remove the main cause of failures (hinge in the middle of the second span), the solution was considered temporary to last for about two years until the restoration works start.

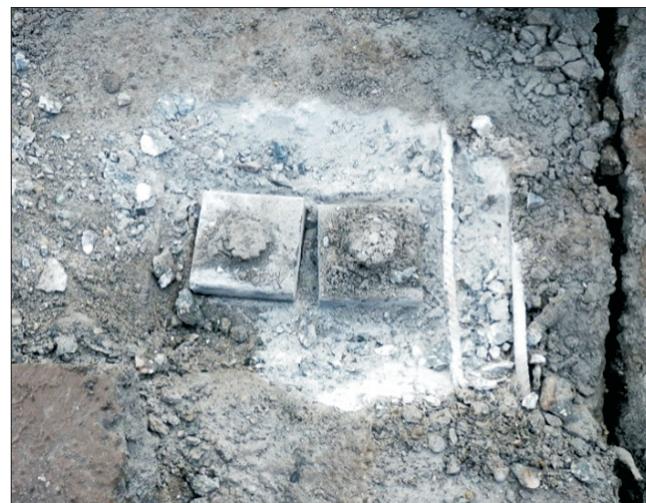
Fig. 5. View at the original upper anchorages of cables

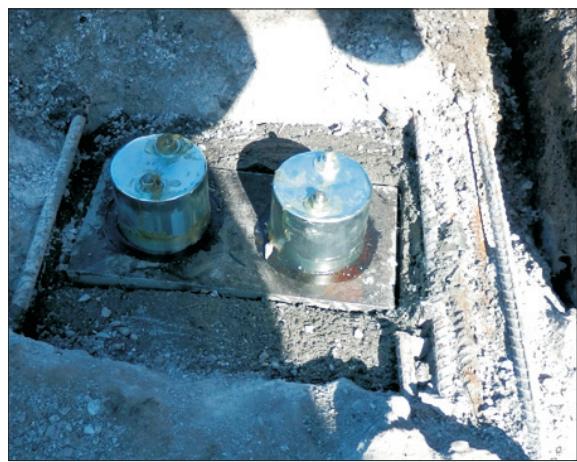
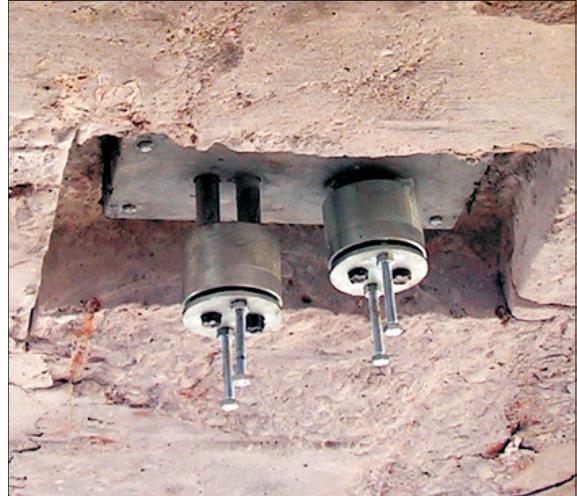
Fig. 7. View on the new bottom (a) and upper (b) cables' anchorage
Rys. 7. Widok nowych dolnych (a) i górnych (b) zakotwień

- measure the position and size of the new openings in the upper and bottom slabs of the box girder made with 60 and 70 mm core drills,
- fabricate custom bearing plates,
- cut new recesses for the bearing plates to match positions of new holes (Fig. 7).

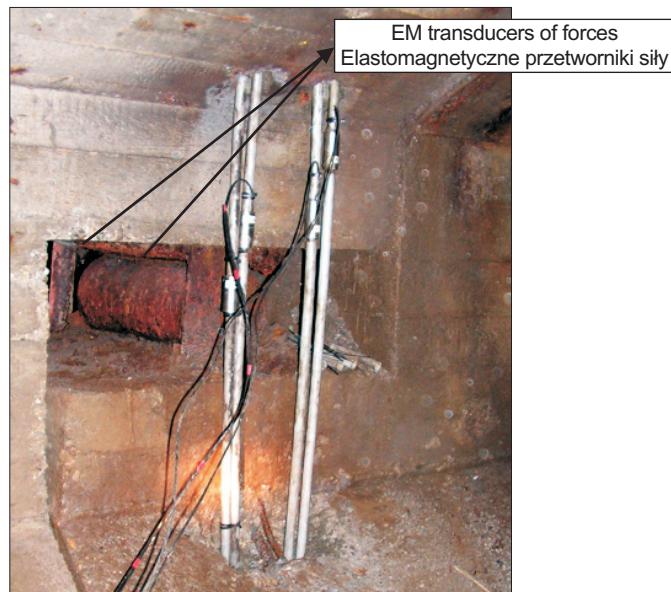
Fig. 8. View at new cables
Rys. 8. Widok nowych kabli

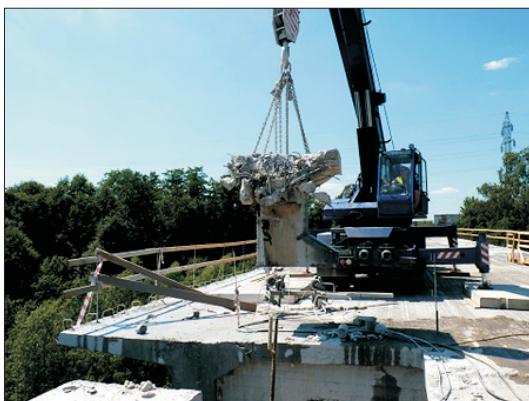
Fig. 12. Removing of the degraded central parts of the bridge in the place of joint

After diversion of traffic from the bridge, milling of the road pavement could begin together with complete removal of the bridge accessory equipment. Subsequently, cutting the central part of the structure, including the damaged joints (steel bearings) was done as one of the most important operations of the entire restoration process (Fig. 12). Further demolition works included removing of the ballast walls on abutments and of the transitional (approach) area. The operations related to removal of the deteriorated parts of the bridge and preparation of the necessary mounting holes were carried out with concrete cutting saws (diamond wire saw and cutting saw types).

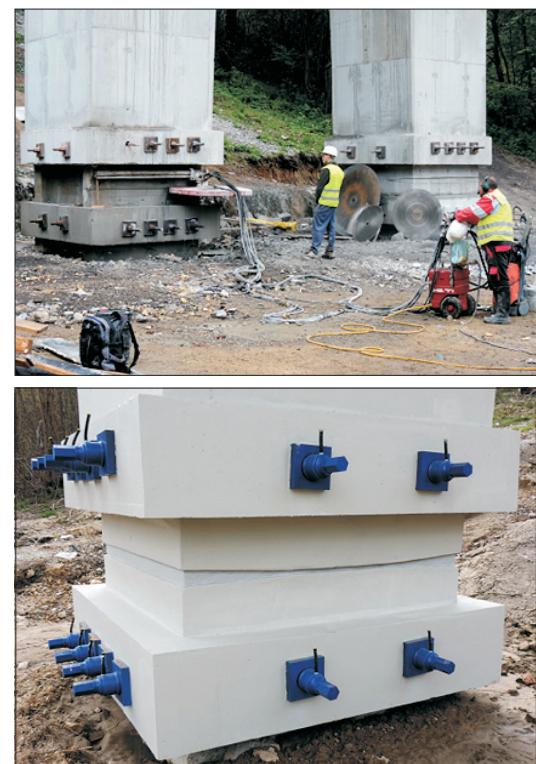
Fig. 13. The notched joint of piers: during (a) and after realisation (b)
Rys. 13. Nacięcie dylatacyjne podpór: w trakcie wykonywania (a) i gotowe (b)

Simultaneously with making cut joints other works were carried out related to comprehensive restoration of external and internal surfaces of the structure. Openings were made and transverse girders and deviators in box girders were concreted for anchoring external cables. At the same time, the piers were strengthened by encasing them with 100 to 150 mm thick layer of reinforced concrete and bearings on abutments were replaced. With the superstructure and piers prepared as described above, the new steel truss anchorage blocks from steel S355 were embedded under the new middle segment of bridge. The effect of prestressing was increased by increasing the eccentricity of cable runs.

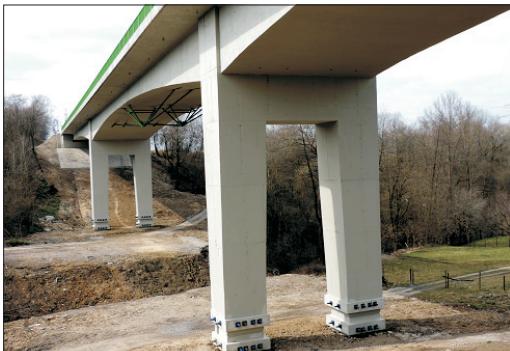
Fig. 14. The bridge substructure and bridge accessory equipment after reconstruction

The bridge restoration project included complete replacement of accessory equipment. A pressure (loading) layer of concrete of varying thickness was placed on top of the superstructure to eliminate irregularities and permanent deflections. Subsequent works were related to concreting the ballast walls on abutments, construction of new approach slabs in the transition areas, installation of complete deck waterproofing system and concreting of fascia girders. Finishing works on the bridge were related to shoulder drainage and expansion joints, installation of vehicle restraint systems, laying the pavement and landscaping around the bridge. In the final stage of construction works, the adjacent areas before and after the bridge of road No. I/18 were restored. The check point of the restoration works was the static loading test which confirmed structural safety of the bridge after strengthening. As such, the traffic could return back to the road No. I/18 from the detour (Fig. 14).

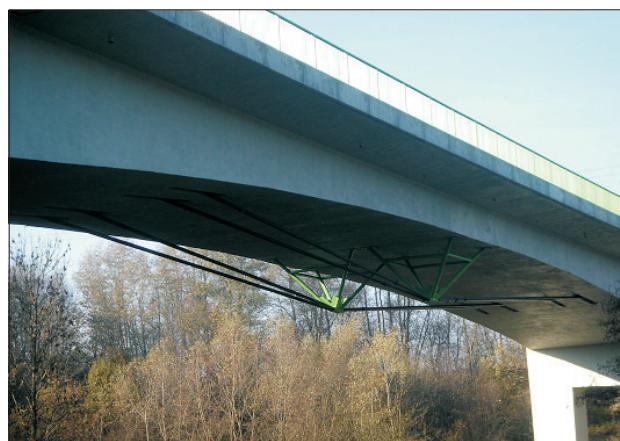
Fig. 15. The detail of the stiffening prestressing structure in the main span

The last step in the strengthening of the superstructure was the prestressing of 4 external cables, each consisting of 22 strands. The strands were made of steel Y1860S7 St 1600/1860, had a diameter of 15.7 mm and a cross-section area of 150 mm². The external cables were continuously entered into the steel deviators, then passed into the box girder through the bottom slab ending on transverse girders over piers where they were anchored on the new concreted deviators. By concreting and prestressing the superstructure and making the new cut joints in the bottom parts of piers the structural system has changed to a compound frame with two hinges.
