GUDRUN GOLKOWSKI<sup>1)</sup>

## LONG LIFE PAVEMENTS WITH RECYCLED CONCRETE IN UNBOUND GRANULAR LAYERS

<sup>1)</sup> Federal Highway Research Institute (BAST), Bergisch Gladbach, Germany; golkowski@bast.de ✉

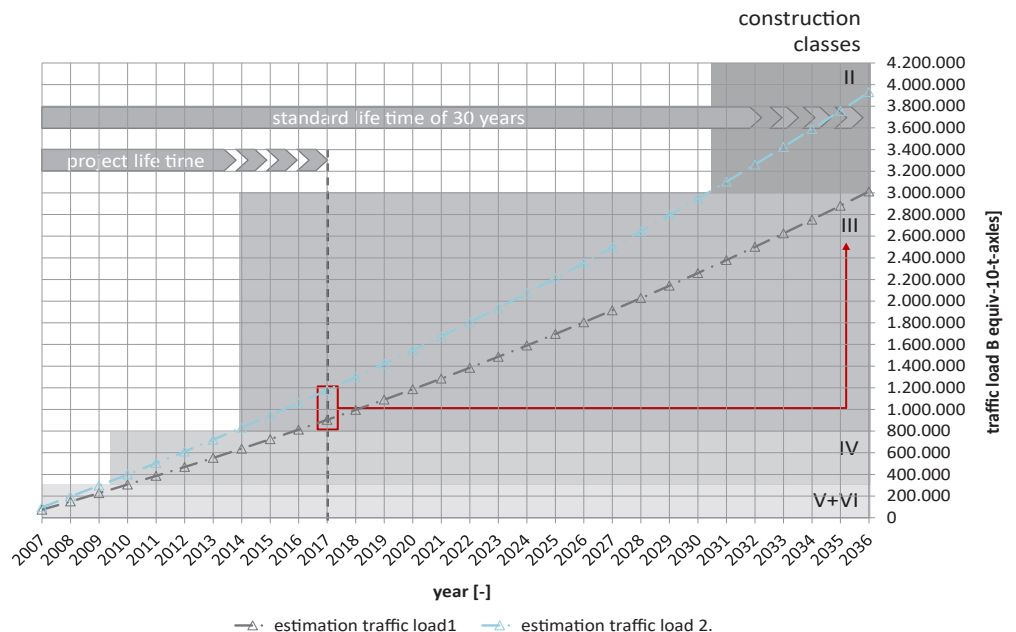
Fig. 1. Evaluation of relevant traffic load for the designed project lifetime

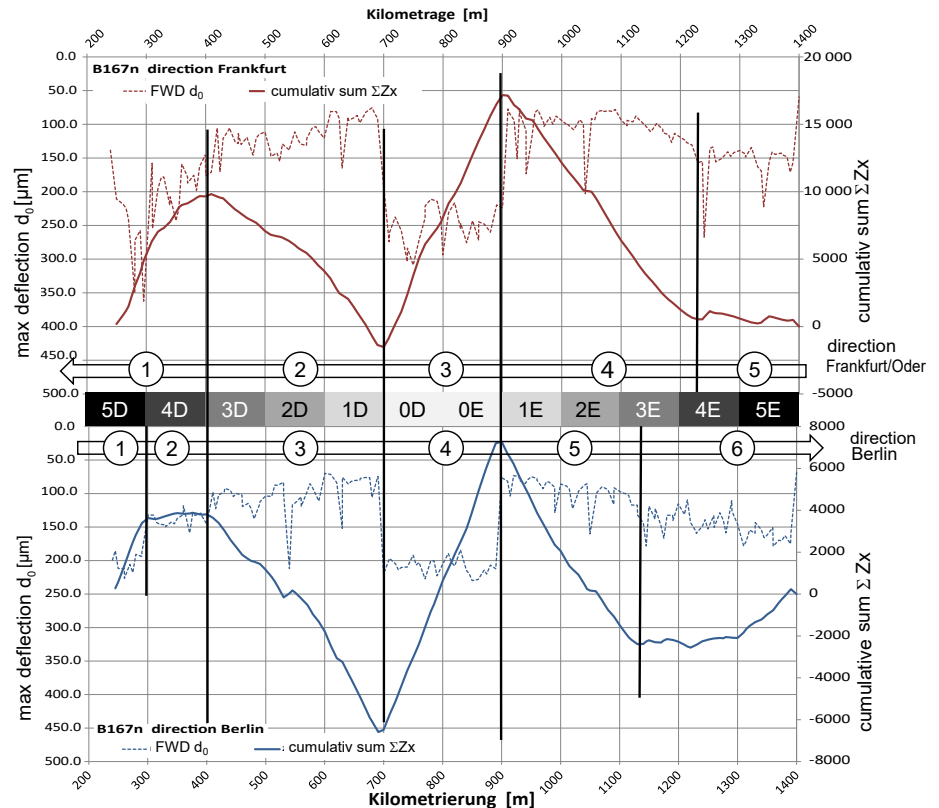
Fig. 4. Profile of FWD measurement of maximum deflection and division into homogenous sections

In a first step it was analysed whether the different subsections could be distinguished based on a computational method for the determination of homogenous sections. For the determination of homogenous sections, the method of cumulative sums for the indicator maximum deflection  $d_0$  was used (Fig. 4). The results show that especially the subsections with natural aggregates (0D, 0E) differ (statistically significantly) from the other sections concerning the maximum deflection of FWD measurements. A clear

separation of the subsections with various fractions of recycled bricks is not possible. Only the sections with a fraction of 40% of recycled bricks (5D, 4D, 4E, 5E) have a significantly lower bearing capacity so that a separation of those subsections is possible.

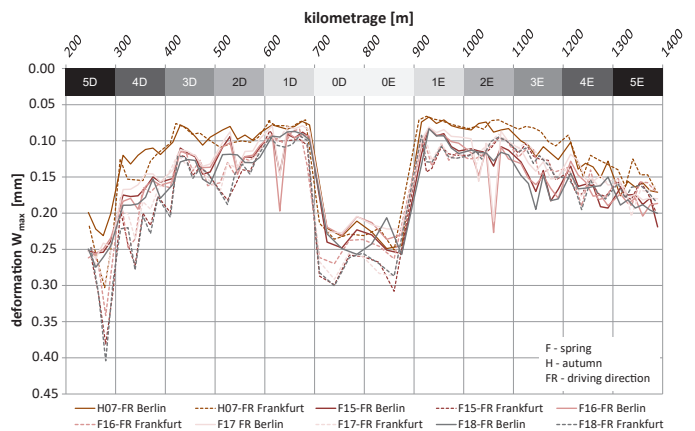
Fig. 7. Profiles of maximum deformation  $w_{max}$  of FWD measurement for the different subsections and both driving directions over the time

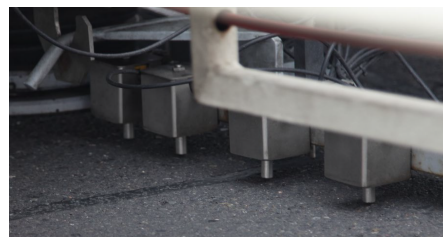
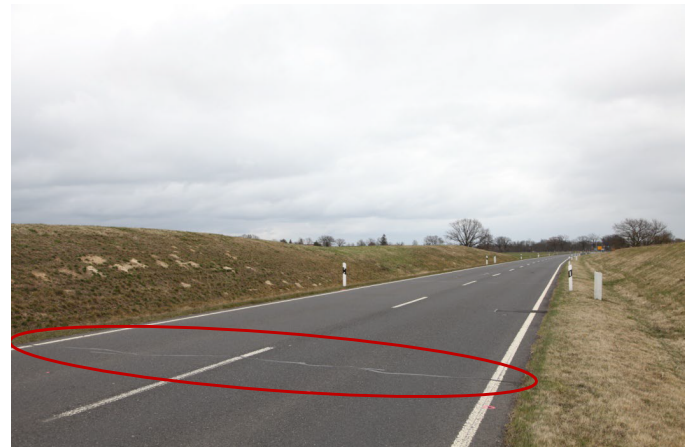
Fig. 9. Discontinuities (cracks) in the asphalt pavement structure

These discontinuities were also visible as cracks at the surface of the asphalt pavement structure (Fig. 9). A detailed surface inspection of the test section was initiated with a detailed recording of surface damage. The test section showed transversal cracks (Fig. 9) in the conspicuous subsections mentioned above. An accumulation of cracks was recorded for subsections (1D/1E and 1D/2E), single cracks also occurred in subsections 3D/3E and 4D/4E. The transversal cracks correspond to the discontinuities in the profiles of the FWD indicators.

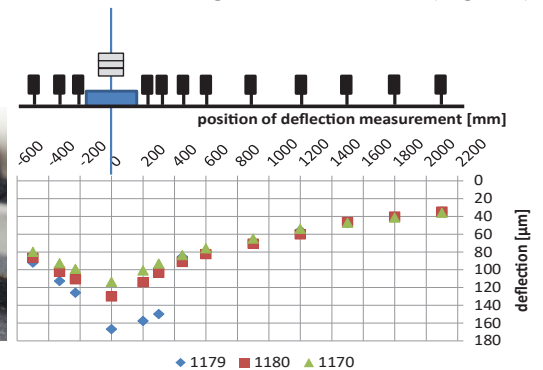
Fig. 10. Discontinuities in FWD indicators due to a crack in asphalt pavement structure at 1179 m in comparison to two measurement points nearby (at 1180 m and 1170 m)

In addition to the regularly executed FWD measurement twice a year, FWD measurements were executed around and directly on some of the transversal cracks (Fig. 10). The measured deflection bowl of the measurements before and behind the crack (green and red dots) do not show any influence of the crack nearby whereas the deflection bowl of the FWD measurement right on the crack (Fig. 10)

show a significant discontinuity (blue dots) between the relevant deflection measurement points (geophones at 300 mm and 450 mm). These measurement results show no distinct area with a loss of bearing capacity so the cracks are punctual defects.

The deflection bowl of the measurement over the crack has a characteristic profile like a joint in concrete pavement. This discontinuity of the deflection bowl signifies a continuous crack through the upper asphalt structure.

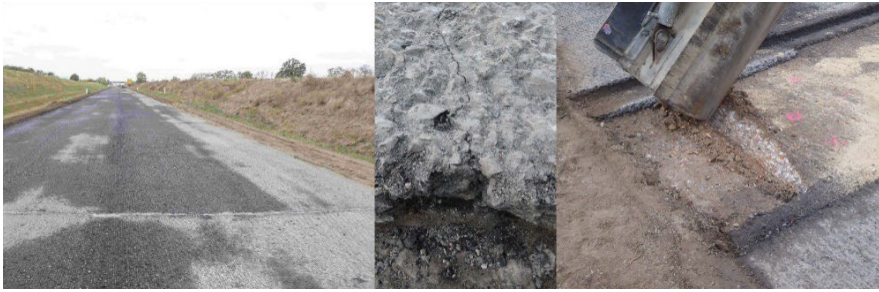
Fig. 11. Visible cracks on top of the asphalt base course and excavation

Due to the observed damage maintenance works were planned and executed in 2018. After milling the asphalt wearing course the cracks were still visible on the asphalt base course. At four subsections (0D, 1D, 3D and 4D) the asphalt base course was also excavated to evaluate the UGLs beneath (Fig. 8). In those excavations (=Ausgrabungen A) measurements with the Lightweight Deflectometer (LFG) and the

Medium Weight Deflectometer (MFG) as dynamic plate loading tests were executed to monitor the deformation modulus of the different UGLs (Fig. 11).

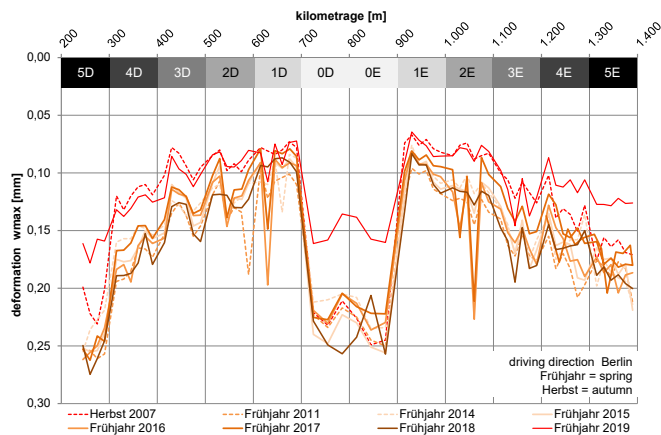
Fig. 13. Results of FWD measurements after maintenance work in comparison to former measurement results

The by-pass of Seelow was subjected to maintenance works in autumn 2018. After finalization of this works FWD measurements were executed to monitor the status quo after the maintenance works in spring 2019 in comparison to the status beforehand (Fig. 13).

An increase of bearing capacity (indicated by less maximum deformation under the loading plate ( $w_{max}$ )) is observed for all subsections after the lifetime of 10 years. Only the subsections with 90% of recycled concrete and only 10% of recycled bricks in the UGL (1D, 1E) point out a very small increase in bearing capacity. This is attributed to the stiffness of the re-bonded recycled concrete in the UGL

The single irregularities of the measurement results – which indicated transversal cracks through the asphalt structure – are still visible, the new binder and wearing course led to a reduction of the irregularities but were not able to compensate these irregularities as the cracks are still present in the asphalt base course even if filled with hot bitumen.

In the subsections with natural aggregates in the UGLs (5D, 5E, 0D, 0E) the bearing capacity increased significantly due to the new thicker construction of the asphalt pavement in comparison to the measurements right after construction of the test section in autumn 2007.

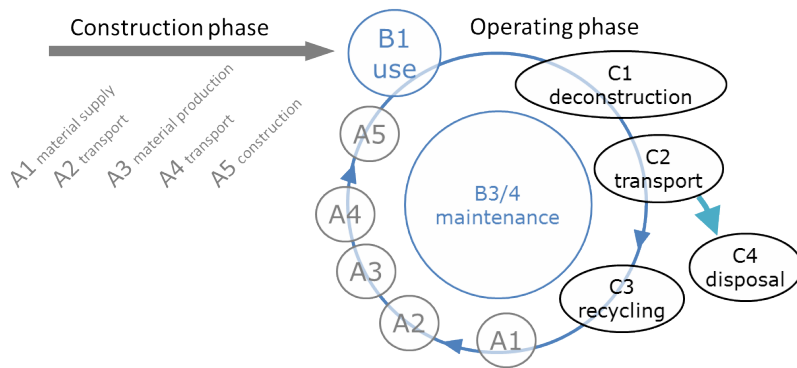
Fig. 14. Lifecycle for pavement construction as basis for the balancing tool "ÖKOPOST" [6]

The tool is based on the following lifecycle (Fig. 14) taking into account the special conditions for pavement constructions and its maintenance works. The tool does not cover a realistic service life for pavements, it is a balancing, mathematical method to compare pavement constructions.
