## The aftermath of a flood: assessing its impact on roads and bridges with insights from the Road and Bridge Research Institute

**Abstract:** The article presents a case study of the activities of the Road and Bridge Research Institute related to the assessment of the technical condition of road and bridge infrastructure in areas affected by a natural disaster in 2024. Particular emphasis is placed on the characteristics of the assessment process and the analysis of inspection results based on 761 preliminary control reports. Floods, as one of the greatest threats to road infrastructure, cause both direct damage and indirect consequences, affecting transportation and interdependent sectors. The article discusses the scale of destruction, the spatial distribution of damage, and the categories of technical condition assessments for bridges and roads. The research findings emphasize the need to implement effective infrastructure protection measures to enhance resilience against future natural disasters. Additionally, they emphasize that assessing the technical condition of bridges and roads should be an integral part of a long-term road infrastructure management strategy during cris

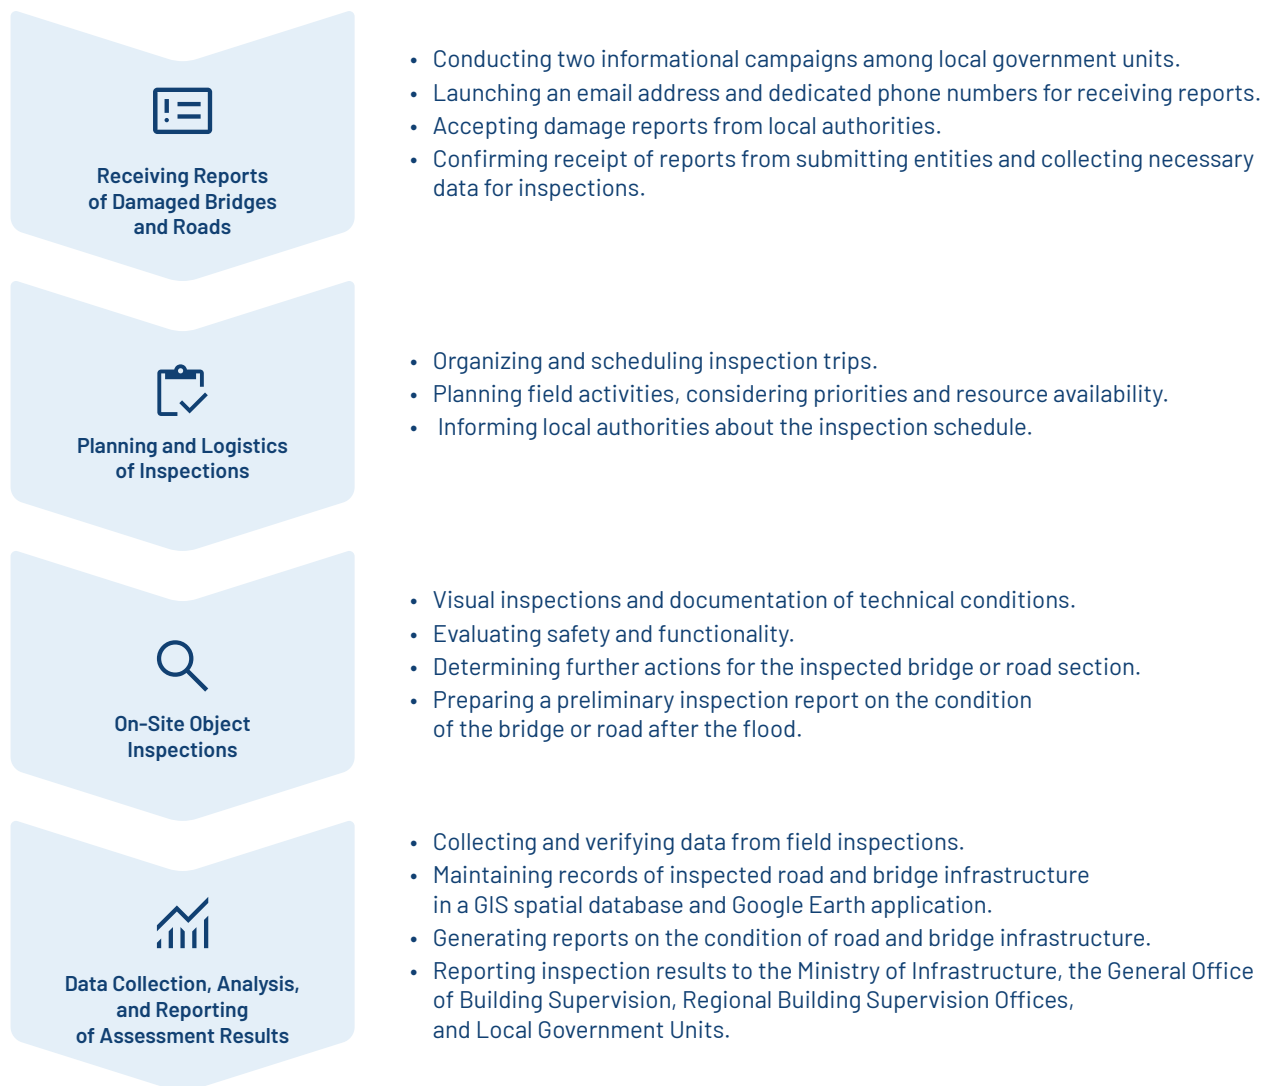
Fig. 5. Diagram of the process for assessing the technical condition of bridge structures and roads

Fig. 5 illustrates the main workflow of activities related to the assessment of structures, whose technical condition was evaluated during inspections. Operationally, the diagram represents the sequence of physical and informational actions performed at various stages, enabling progression through subsequent phases of the process. The task began with the launch of two separate information campaigns: one for bridge inspections and the other for road inspections. These campaigns targeted local government units located in areas affected by the state of natural disaster.

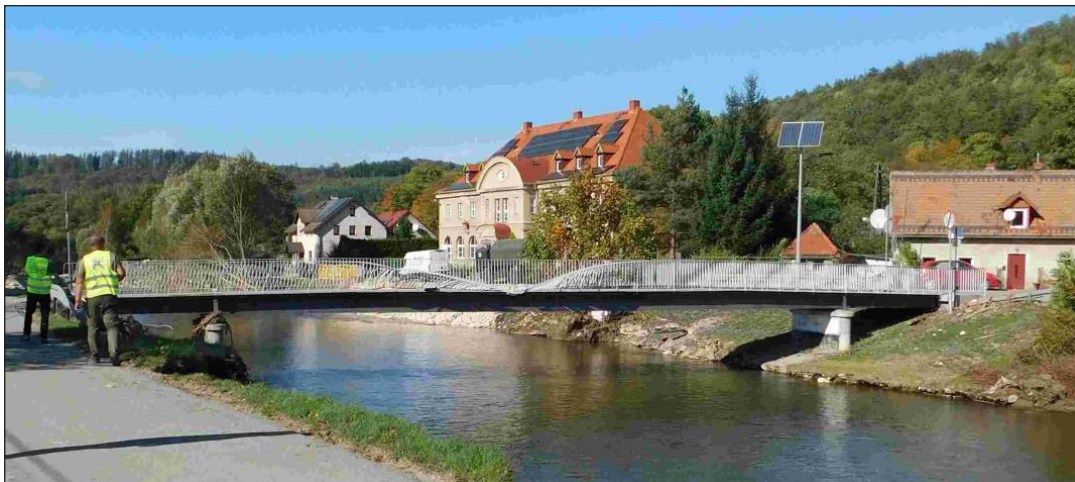
Fig. 7 presents the characteristics of a sample bridge structure classified as category C. Inspection results show that the bridge in Kłodzko suffered significant damage due to the flood, requiring its immediate closure and a more detailed technical assessment. Key repair actions include stabilizing the foundation of the piers, repairing the displaced load-bearing structure, and replacing the railings to ensure pedestrian safety. Urgent intervention by the road authority is necessary to carry out the required construction and maintenance work.

**Condition of abutments and piers:** Scouring of the pier on the Wodna Street side – foundation expertise required, damage to reinforcements near abutments and piers.

**Condition of the load-bearing structure of spans:** Displacement of the load-bearing structure by 2-5 mm downstream – possible span rotation, requiring expertise and repairs. Local damage to the steel girder due to impact from debris carried by the water.

**Condition of the roadway surface:** No visible flood-related damage.

**Condition of access roads:** Damaged barriers on the access road from Wodna Street.

**Condition of the surrounding area:** Deformed and damaged railing – urgent replacement required. Lack of pedestrian safety measures necessitates the closure of the structure. Deformed and damaged embankments and riverbed reinforcements.

**Decision:** the bridge is not approved for use, a technical assessment of the pier foundation and load-bearing structure is required, repair work should be carried out, including pier stabilization, load-bearing structure repairs, and railing replacement.

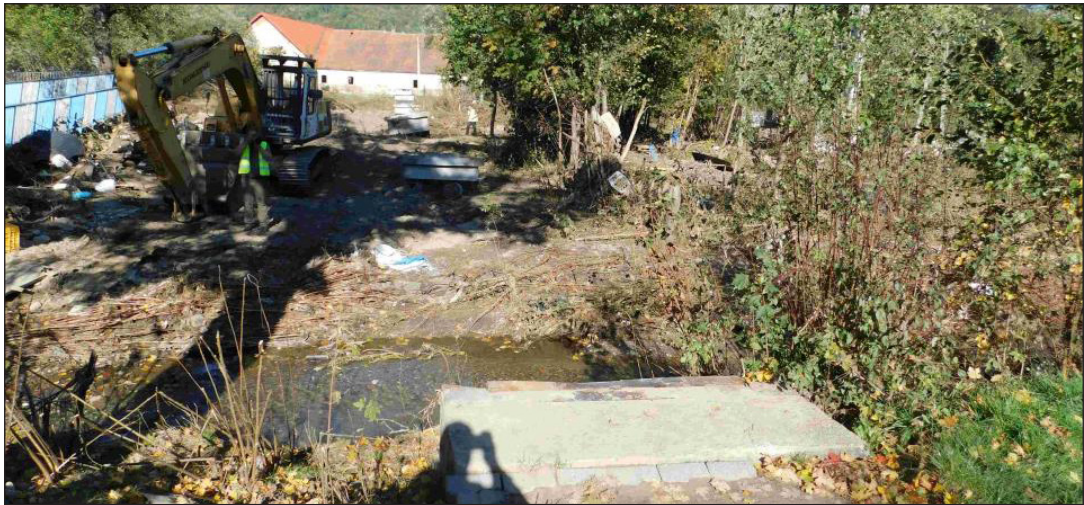
Fig. 8 presents the characteristics of a bridge structure classified as category D. The technical assessment of the bridge in Oldrzychowice Kłodzkie indicated severe flood damage, making further use of the structure impossible. The decision to demolish and build a temporary crossing is essential for ensuring safety and maintaining regional connectivity. Preventive measures should be considered in future projects to enhance the durability of the new structure in the face of extreme weather events.

**Main piers:** Damaged, deformed, and undermined.

**Road surface:** Bridge entirely destroyed.

**Surroundings:** Cleanup work is required, including removing the damaged load-bearing structure.

**Decision:** Complete demolition of the bridge is necessary due to extensive damage. A temporary crossing should be arranged to maintain connectivity. A hydrotechnical analysis should be conducted to assess risk factors for future projects. It is recommended to modernize or rebuild the structure in a way that enhances its resilience to future flooding.

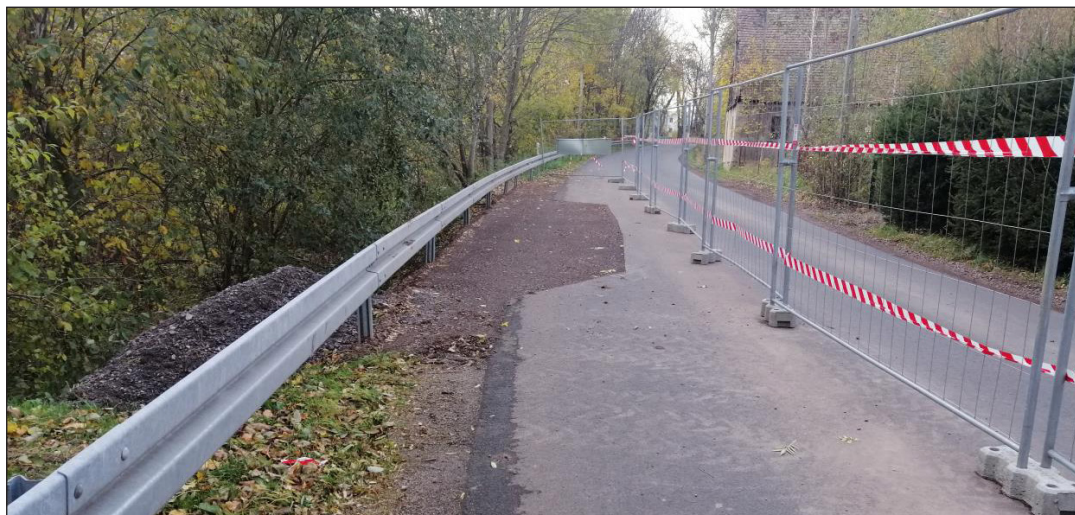
Fig. 10. Description of the road section with a rating of D

Fig. 10 presents the characteristics of a road section classified as Category D. The road section in Rybnica Leśna suffered severe damage due to extreme weather conditions, resulting in slope failure, pavement destruction, and shoulder collapse. Despite the road authority's attempt to secure the damaged area by filling it with aggregate, the appearance of cracks indicates continued instability of the roadbed. Further use of the road is impossible without repairs. The priority action should be restoring slope stability through the reconstruction of the retaining wall.

**Pavement:** Completely destroyed over a length of approximately 12 meters and a width of 1.3 meters.

**Culverts:** No culvert present at the damaged site.

**Retaining wall:** The existing stone retaining wall was destroyed in sections before and after the damaged area.

**Traffic safety devices:** Energy-absorbing barriers remain in good condition.

**Decision:** the retaining wall must be reconstructed to ensure road stability, further expert evaluation is required to determine the detailed scope of repairs.

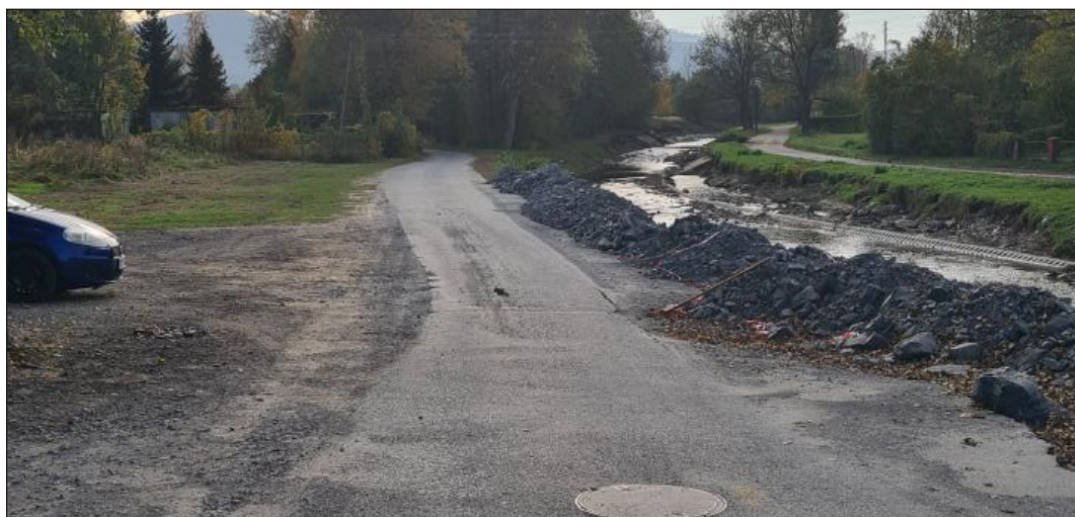
**Pavement:** The river eroded the slope along a 65-meter section, leading to the destruction of one traffic lane.

**Culverts, Traffic safety devices, other damages:** Not applicable to this section.

Fig. 11 presents the characteristics of a road section classified as Category E. The assessed road section in Prudnik has suffered severe damage due to flooding. It is necessary to carry out repairs, rebuild the damaged traffic lane, and conduct an additional expert assessment. The roadside on the river side has ceased to exist, and the road can only be used to a limited extent. Therefore, it is recommended to construct a temporary road and conduct further analyses to develop a repair plan.

**Decision:** Road reconstruction/repair is necessary to restore full traffic flow, if repairs are delayed, a temporary single-lane road must be built, an additional expert assessment should be conducted to determine methods for stabilizing the slope and preventing further degradation.
