PETER KOTEŠ¹⁾
MIROSLAV BRODŇAN²⁾
MILAN CHANDOGA³⁾
TATIANA BACÍKOVÁ⁴⁾
WOJCIECH KUBISSA⁵⁾

THE ZLATNÉ BRIDGE - CONDITION SURVEY, TEMPORARY REMEDIAL WORKS REQUIRED DUE TO DANGEROUS CONDITION AND BRIDGE RESTORATION PROJECT

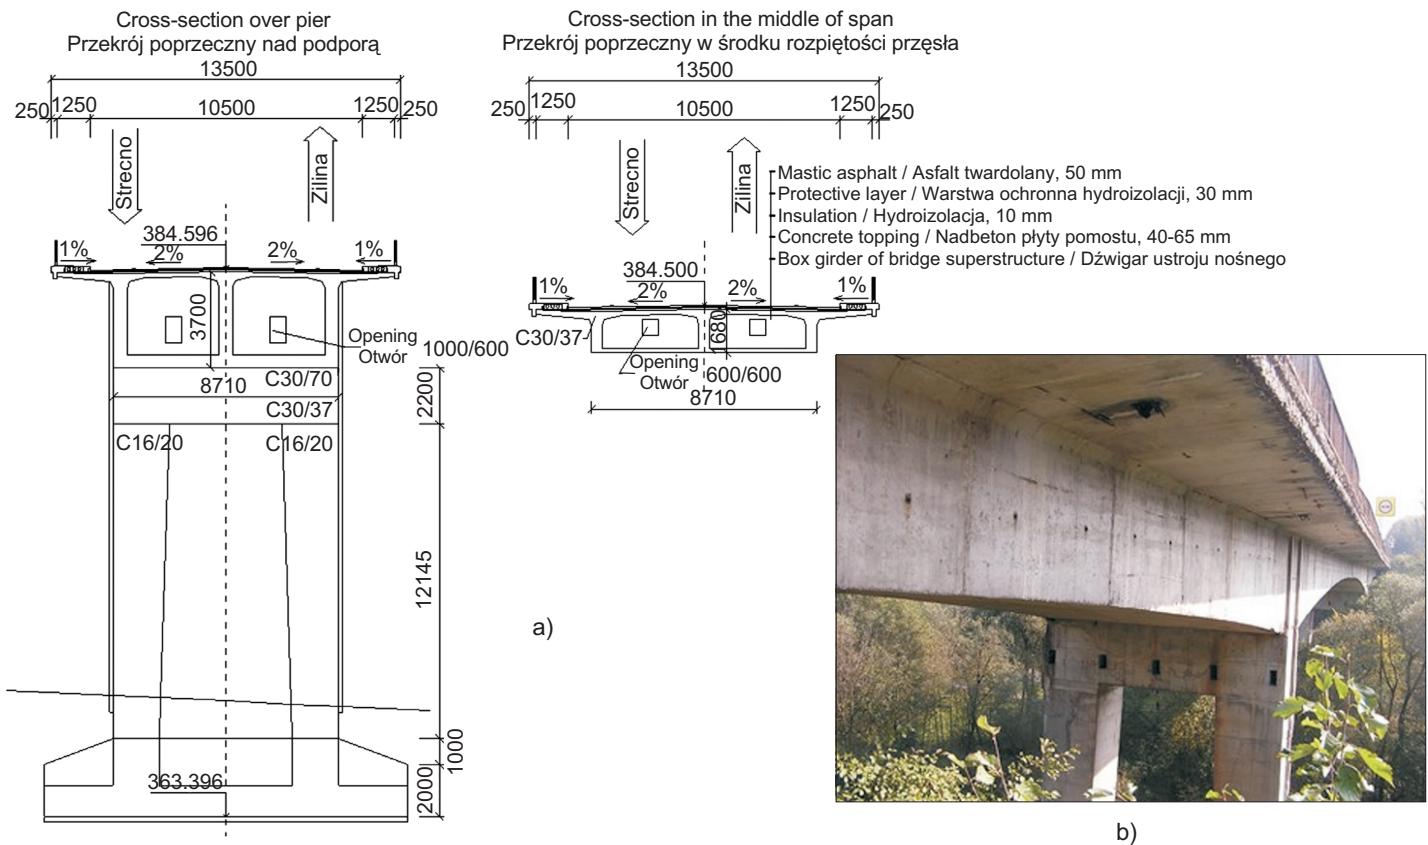
Fig. 1. The view of the bridge before the reconstruction: a) cross sections, b) view
Rys. 1. Widok mostu przed remontem: a) przekroje, b) widok

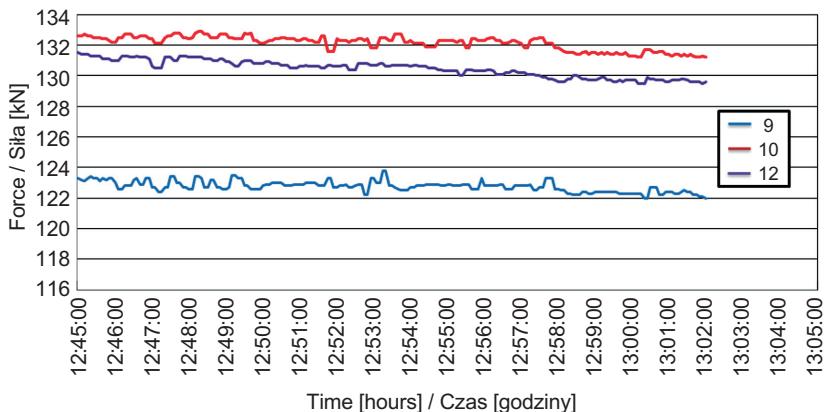
Fig. 6. Changes of stressing in strands No. 9, 10 and 12 due to variable loads during the single lane traffic

during the bridge operation (under traffic) are presented in Fig. 6. The maximum force occurred in strand No. 6:

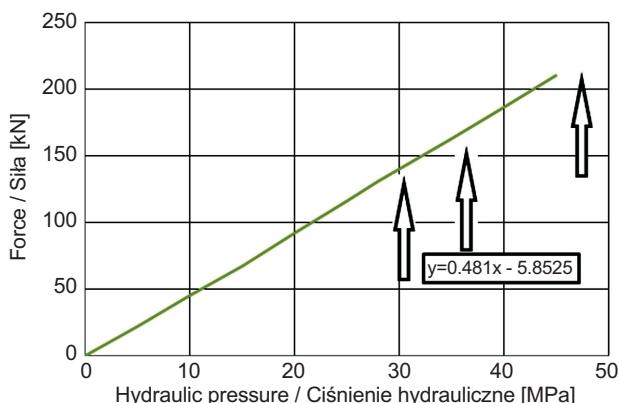
Fig. 9. Calibration of prestressing tool PAUL TENSA SM 240 kN with strand Monostrand using dynamometer PAUL DMS 500 kN with accuracy +/- 0.5%

The stressing jack was calibrated with PAUL dynamometer (Fig. 9) before stressing the strands. The check measurements done with elastomagnetic force transducers PSS20 (Fig. 10) confirmed calibration values for 290, 350, 450 bars. This procedure allows to measure the forces in strands with an accuracy of +/- 1 kN. The stressing operation started with the outermost cable (composed of two strands) of the lane heading to Strečno. After prestressing of the first cable the bearing in joint was closed. The cable near the centre bearing was selected to monitor the changes of force in cables during stressing of the consecutive strands (Figs. 6 and 11).

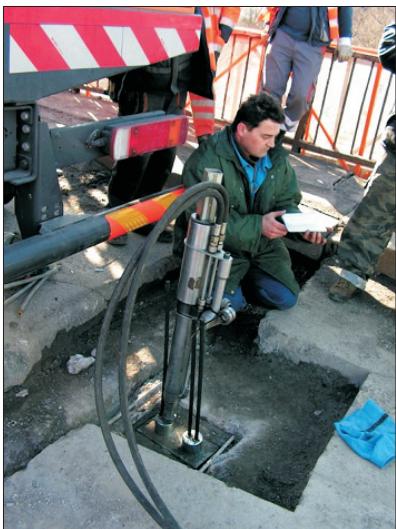
Fig. 10. Strand prestressing using tool PAUL
Rys. 10. Naciąg cięgien przy użyciu prasy PAUL

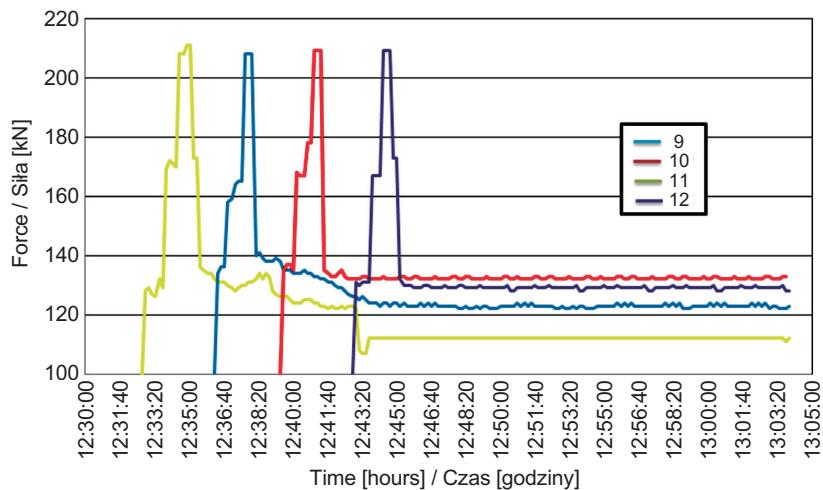
Fig. 11. Forces in strands no. 9-12 in the middle of the bridge cross-section
Rys. 11. Siły w splotach 9-12 w środkowej części przekroju poprzecznego mostu
